GEOGRAPHY PROJECT REPORT
2022-23

Title of the Report: 'River Overflow Flood in the Tamluk Municipality during the Yaas Cyclone of May, 2021'

Place Visited: Tamluk Municipality, Purba Medinipur District, West Bengal

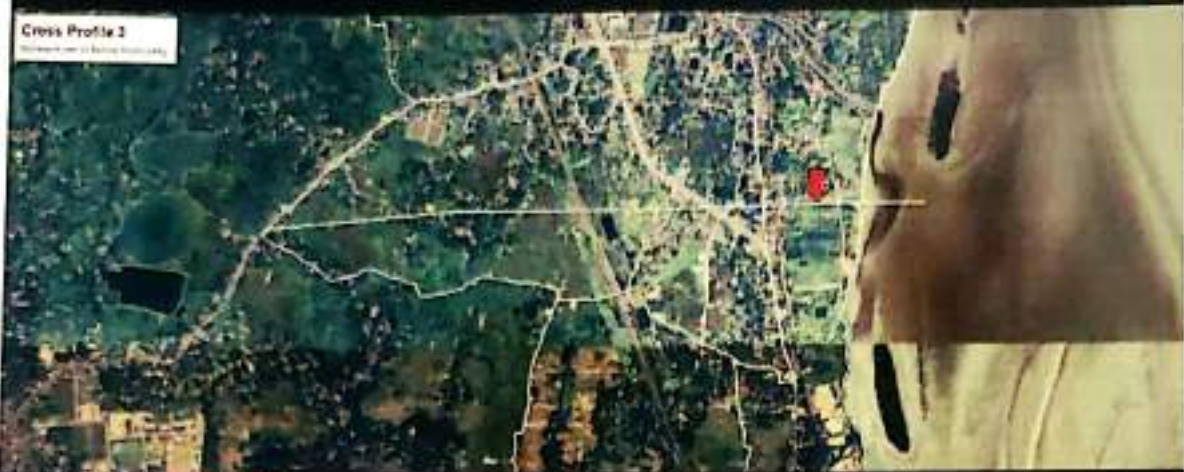
Cross Profile 3

Graph Min. Avg. Max. Elevation: 25.5m - 29.6m
 Range Total Distance: 3.17 km - Elevation: 25.5m - 29.6m - Max. Slope: 5.6% - 3.8% - Avg. Slope: 1.9% - 1.7%

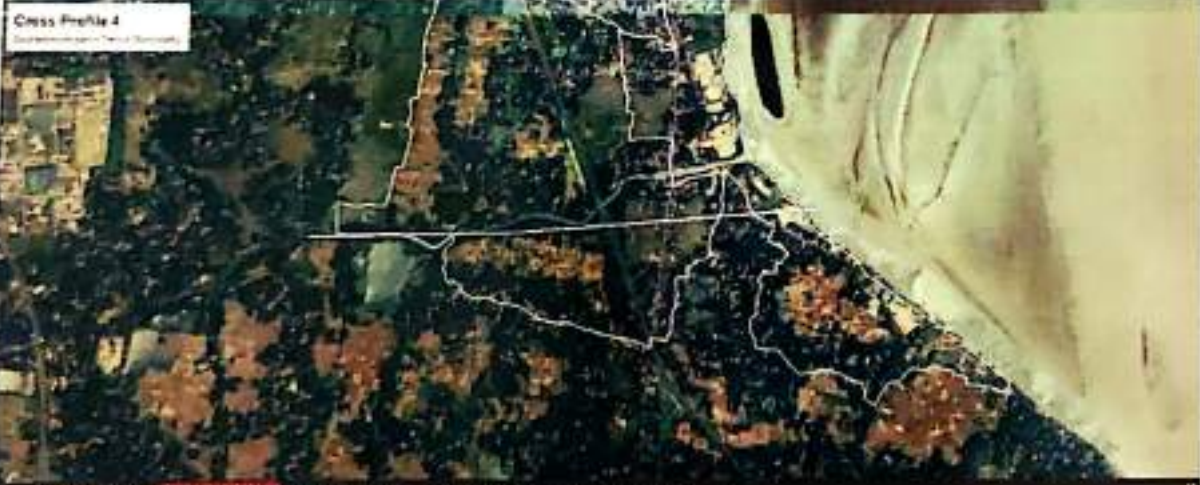
Cross Profile 4

Graph Min. Avg. Max. Elevation: 14.3m - 16.1m
 Range Total Distance: 2.35 km - Elevation: 14.3m - 16.1m - Max. Slope: 3.9% - 3.1% - Avg. Slope: 1.2% - 1.1%

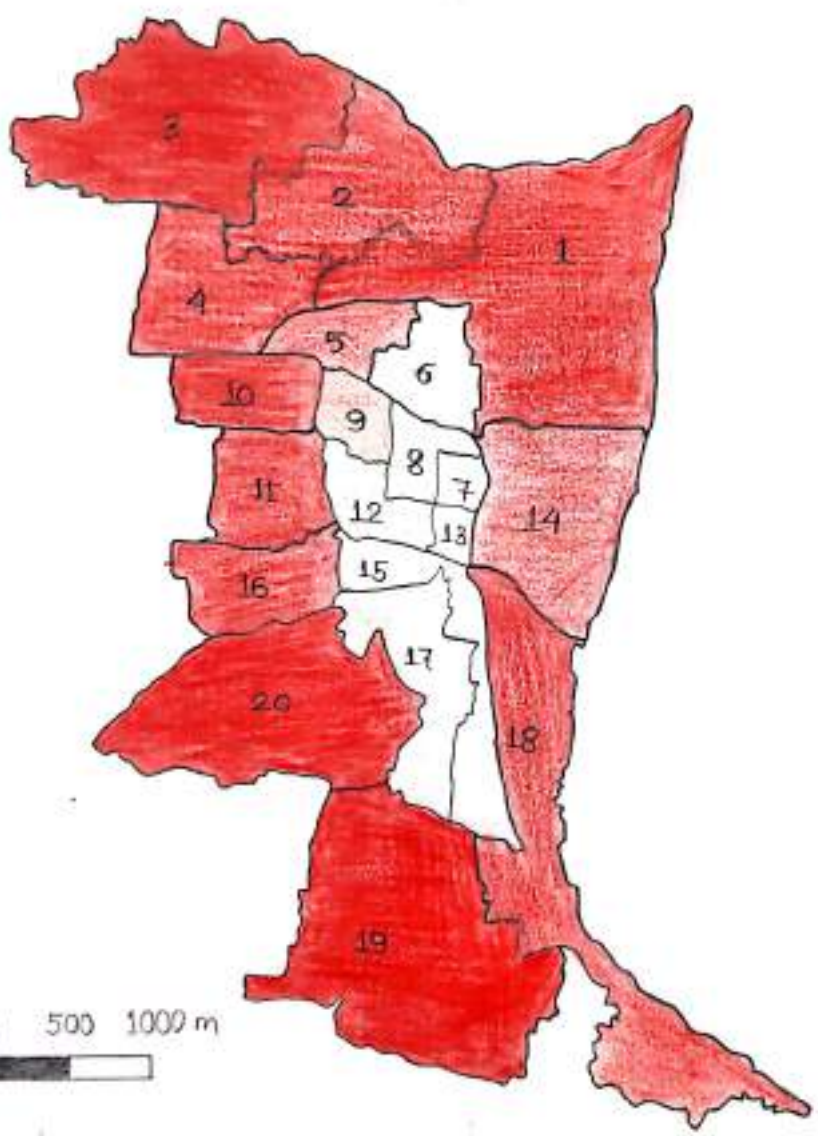
FLOOD RISK ANALYSIS SCORE TAMLUK MUNICIPALITY

Flood risk assessment analysis shows that apart from the older central part of the town the outer wards both along the riverbank and on the western margin are at risk because of the lower elevation and slopes. Wards 03, 19, and 20 are mostly susceptible to pluvial floods while wards 01, 14, and 18 are at risk of both pluvial and overtopping or embankment breaching flood. With the current rate of sea level rise the river bank wards are also under the threat of future overtopping and inundation.

INDEX	
	Very high (16-20)
	High (12-14)
	Moderate (10-11)
	Low (7-9)
	Very low (<7)

From flood inundation analysis and Google Earth data on selected parameters for flood risk assessment of the wards of the municipality were extracted. Here the selected parameters were ward-wise % wise % of inundated area, centroid distance from riverbank, and average elevation of the ward. A flood risk assessment map was prepared by standardising the data using Z-Score.

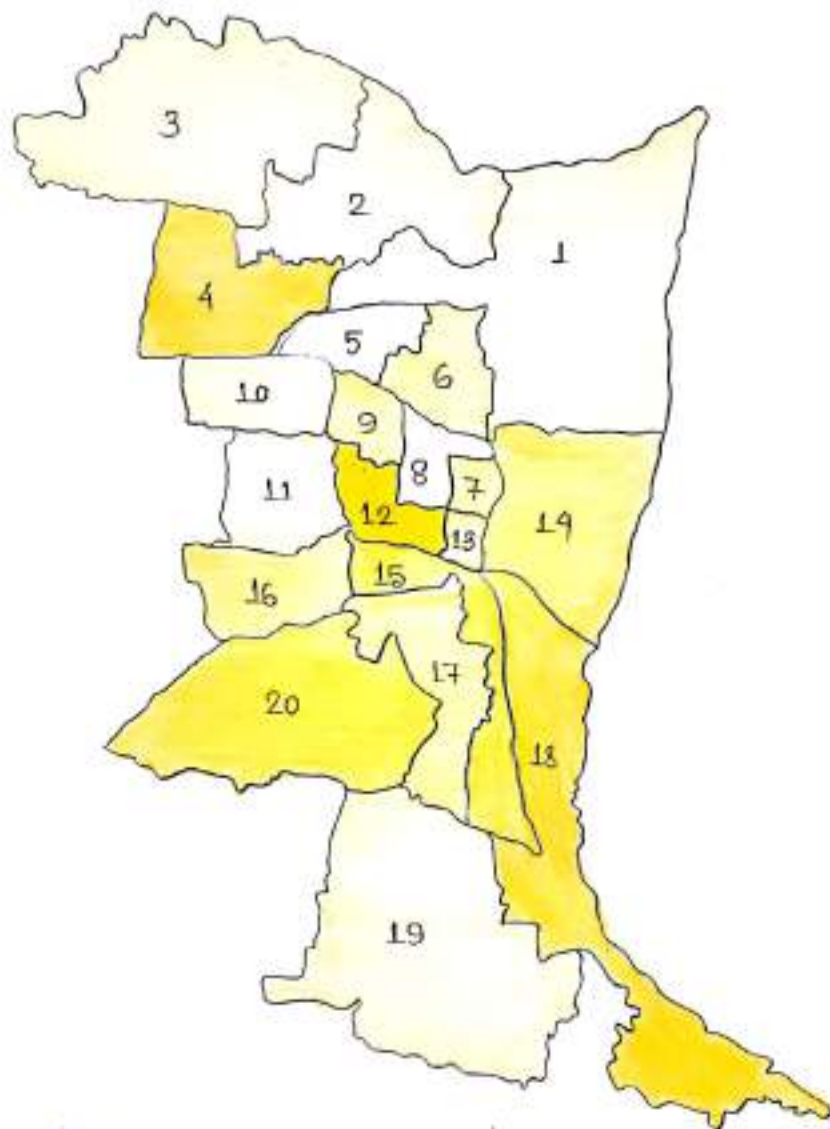
SOCIAL VULNERABILITY SCORE TAMLUK MUNICIPALITY

The social vulnerability analysis shows that wards 04, 12, 15, 20, and 18 are vulnerable considering the demographic parameters taken in this study. The composite score shows that the western wards are more vulnerable due to high risk of pluvial flooding, high population density and social backwardness while in case of river margin wards, due to their low population densities they are showing moderate to high vulnerabilities. From this analysis it is observed that the ward no. 18 is at risk of pluvial flood, overtopping and bank erosion along with a high population density.

INDEX SOCIAL VULNERABILITY	
	Very High (>15)
	High (13-15)
	Moderate (11-13)
	Low (9-11)
	Very Low (<9)

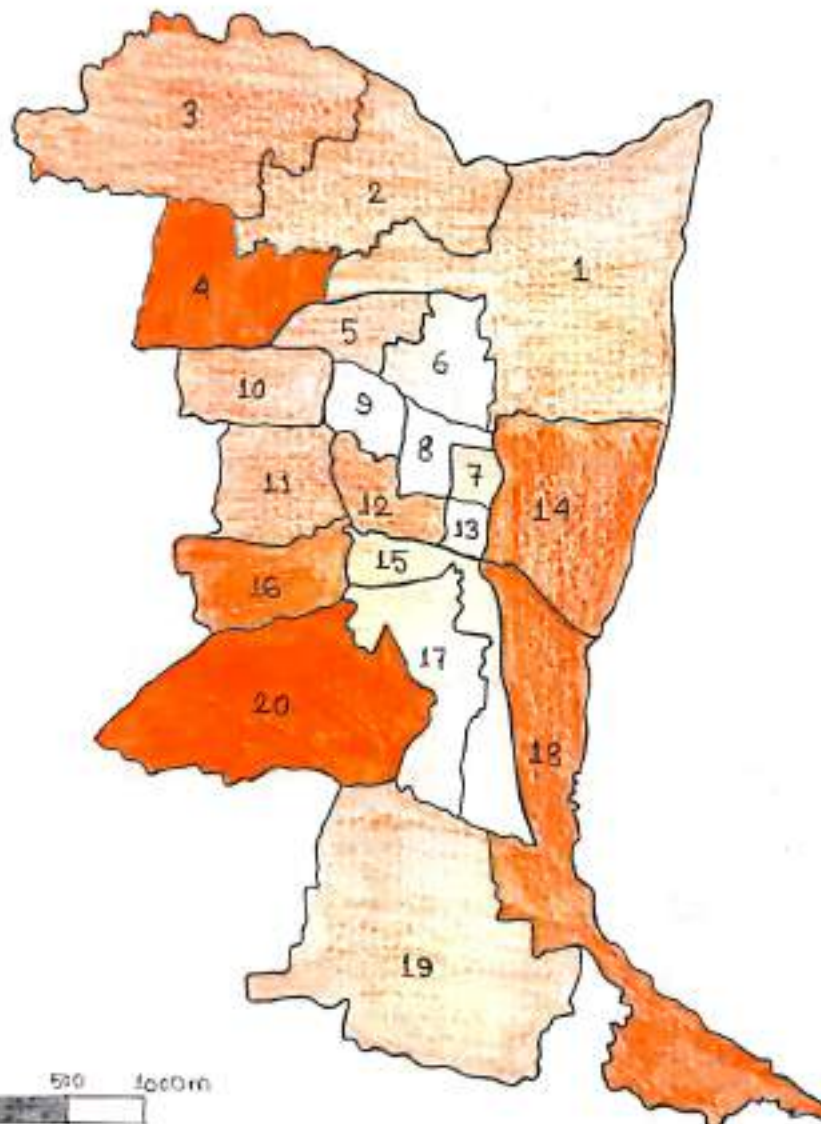
COMPOSITE VULNERABILITY SCORE TAMLUK MUNICIPALITY

INDEX	
	Very High (>170)
	High (130-170)
	Moderate (90-130)
	Low (50-90)
	Very low (<50)

By multiplying flood risk score and Social Vulnerability score a composite vulnerability score was computed for the wards of the Tamluk Municipality.

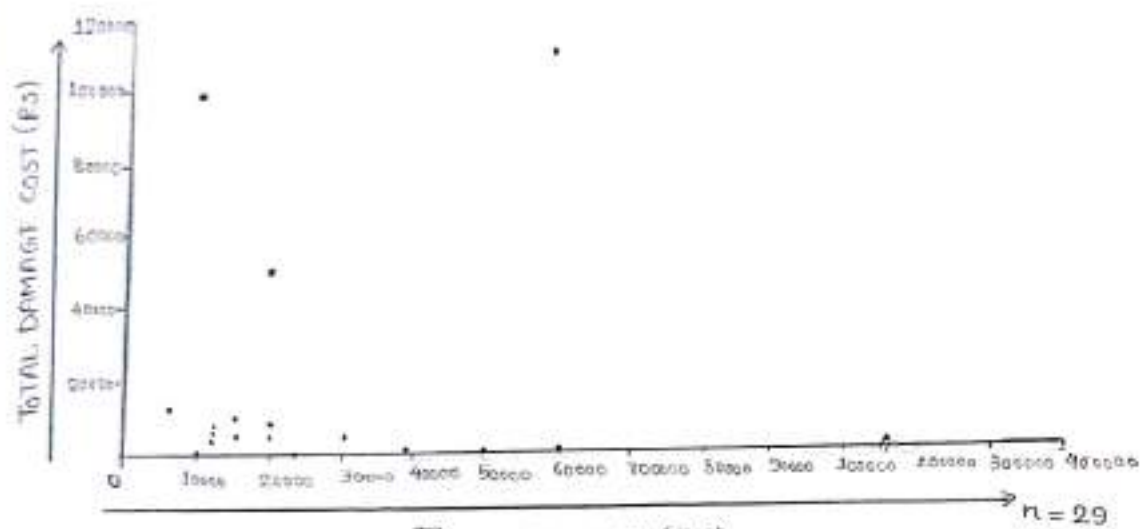
RELATION BETWEEN FAMILY INCOME AND TOTAL DAMAGE COST

(iv) There is definite relation between family income and damage cost. The damages are more for the rich having various electronic gadgets, cars, motorbikes placed on garage or ground floor while low-income people lost mostly of their everyday belongings.
